FLT OPS / TECH / 80/Oct 17, 2024

Subject : OPEARATIONAL INTERRUPTUONS DUE TO “AIR PACK x REGUL FAULT

**OPERATIONS ENGINEERING
TECHNICAL BULLETIN**

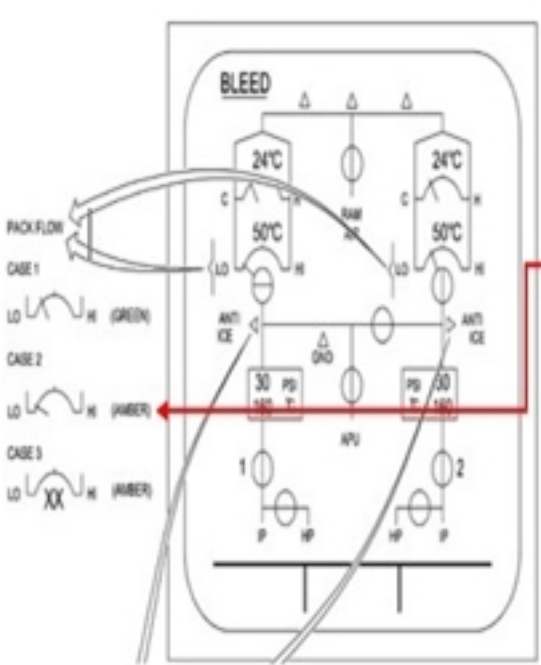
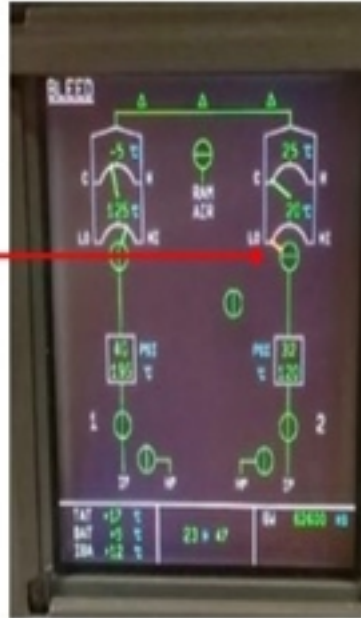
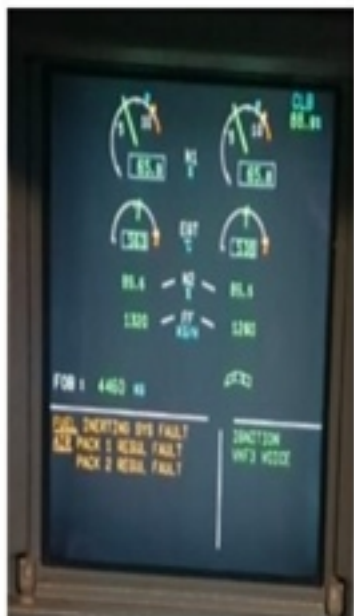
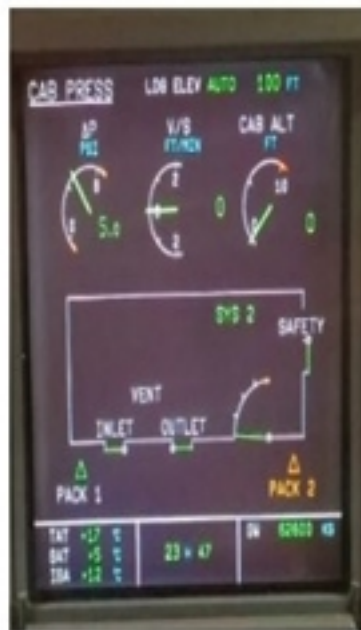
In recent past, PIAC had similar unique events due to “AIR PACK REGUL FAULT”. With no alert or fault till cruise FL350, “CAB PR: EXCESS CAB ALT” warning was triggered as cabin found climbing. This was due to the fact that cabin was being pressurized in actual with a Single Pack only that too in ‘NORM’ Pack Flow configuration, whereas as loss of the other pack remains spurious to crew. It was revealed from the Post Flight Report that “AIR PACK 2 REGUL FAULT” was observed during Engine Start prior departure, yet no ECAM alert was generated. From the attached snapshots that were taken once aircraft descended to 14,000 FT, it was revealed that Pack 2 Flow Valve was showing almost CLOSED with amber line and once ECAM RCL was pressed, amber “AIR PACK 1 REGUL FAULT” and “AIR PACK 2 REGUL FAULT” were displayed.

As per FCOM ‘Abnormal and Emergency procedures’ of AIR PACK 1(2) REGUL FAULT, this alert is triggered once the Pack main channel has failed or Pack Main and Secondary channels are failed. The pack flow is fixed at previous settings. Owing to the serious impact of such “AIR PACK REGUL FAULT” on flight that could silently lead to loss of the other pack which remains spurious to crew, following is recommended to avoid an event:

1. Press RCL – Check for any **AIR PACK REGUL FAULT** messages

1. Check for any 'amber' sign on Pack x Valve and/or
2. Check if Pack valve showing CLOSE or modulating fully towards CLOSE

1. First set PACK FLOW to HIGH
2. Perform a RESET of affected PACK P/B SW
