# BOEING COMMERCIAL AIRPLANES

## FLIGHT OPERATIONS TECHNICAL BULLETIN

**NUMBER:** 777-47 R3

**SUBJECT:** Global Positioning System (GPS) Signal Interference

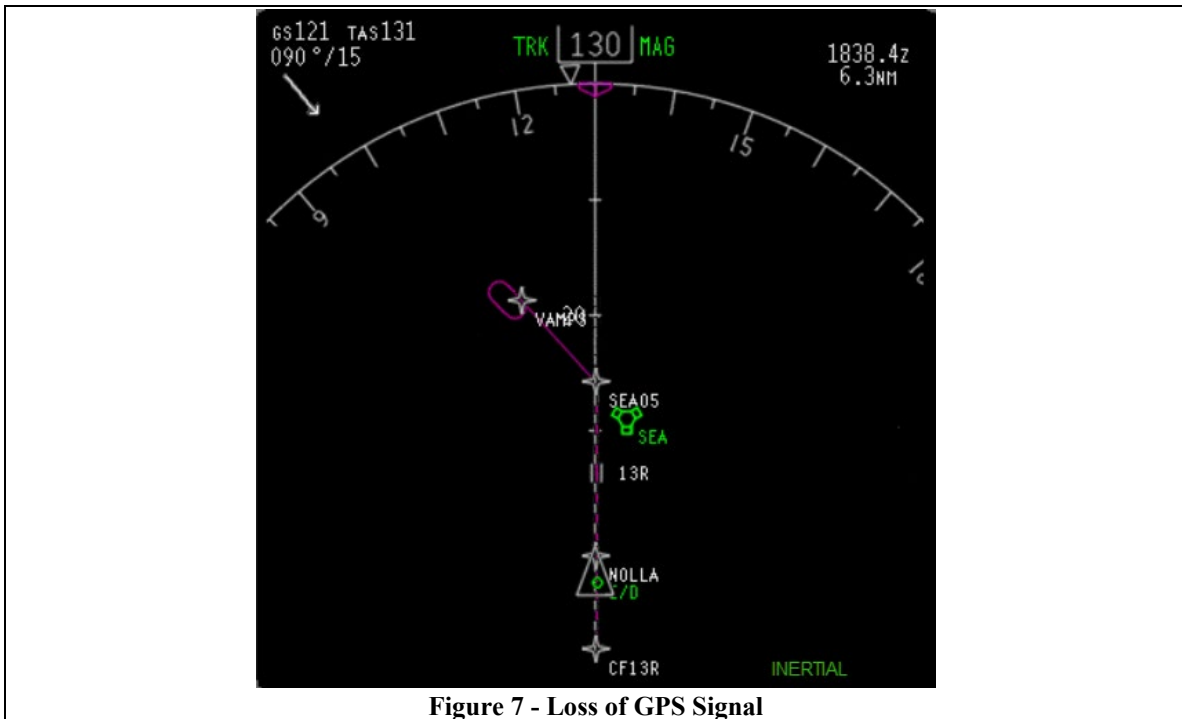
Figure 7 - Loss of GPS Signal

When GPS or radio updating are not available, INERTIAL is displayed as the FMC Position Update Status on the ND. See Figure 7 below.

Selecting RAD NAV INHIBIT “OFF” on the REF NAV DATA page enables radio updating. Details are covered in the Navaid Inhibit or Enable Supplementary Procedure in Volume 1 of the Flight Crew Operations Manual (FCOM). Selecting RAD NAV INHIBIT “OFF” allows conventional navigation aids like DME-DME or VOR-DME to update the FMC position provided they are in range with proper geometry. A change of the update source from inertial to radio updating can cause a slight map shift.

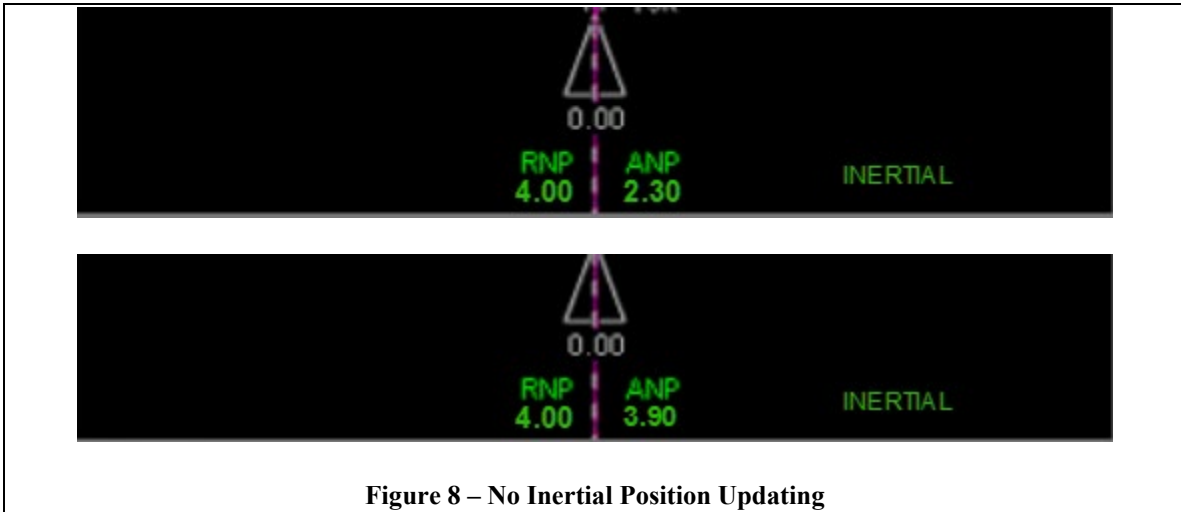
Due to inertial drift, the ANP continues to increase as shown in Figure 8 below.

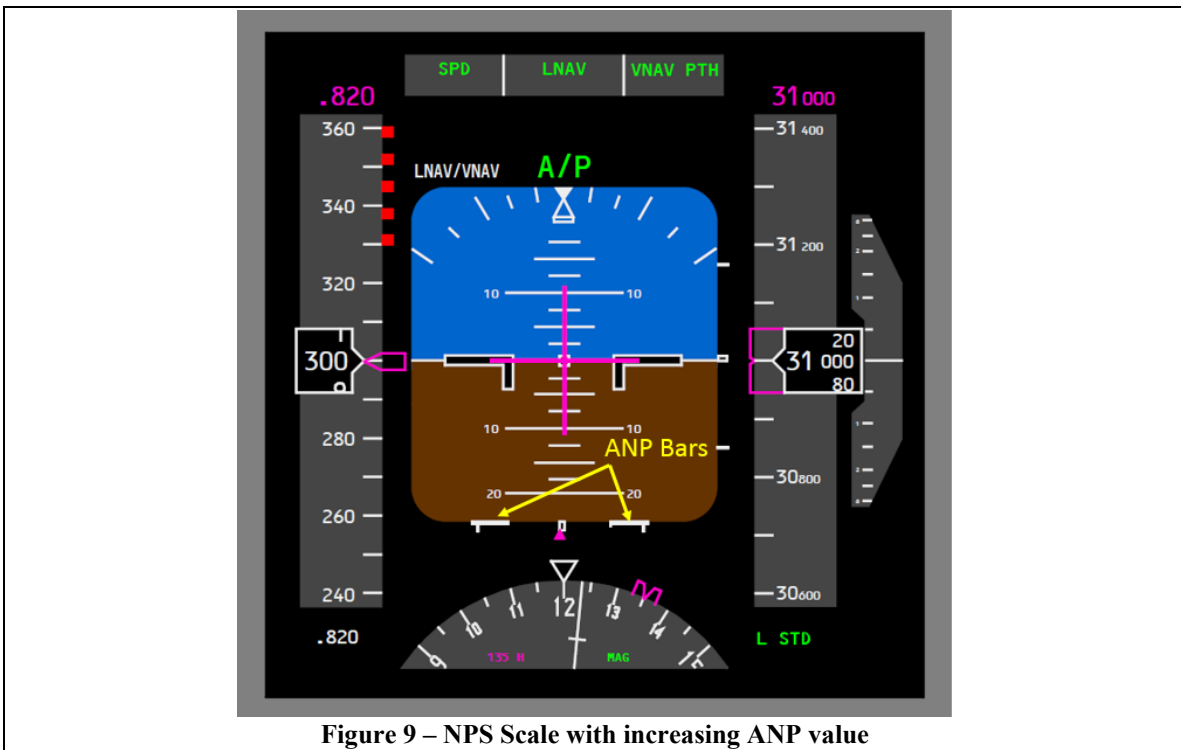
For airplanes with Navigation Performance Scales (NPS), the PFD also shows the increasing ANP value. See Figure 9.

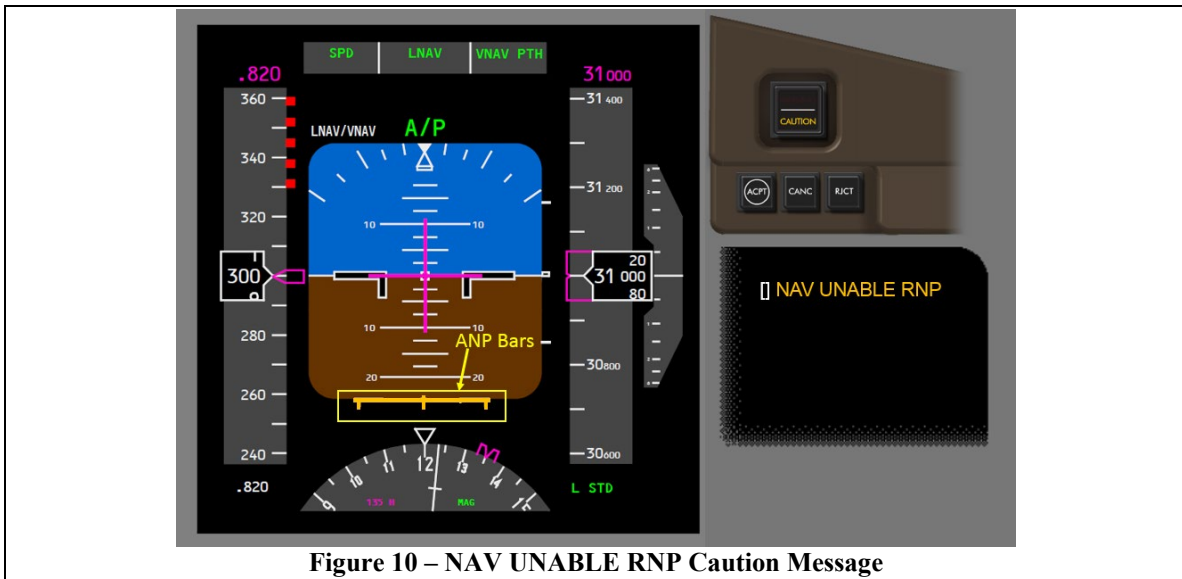
When ANP exceeds RNP, the NAV UNABLE RNP message shows as shown in Figure 10.

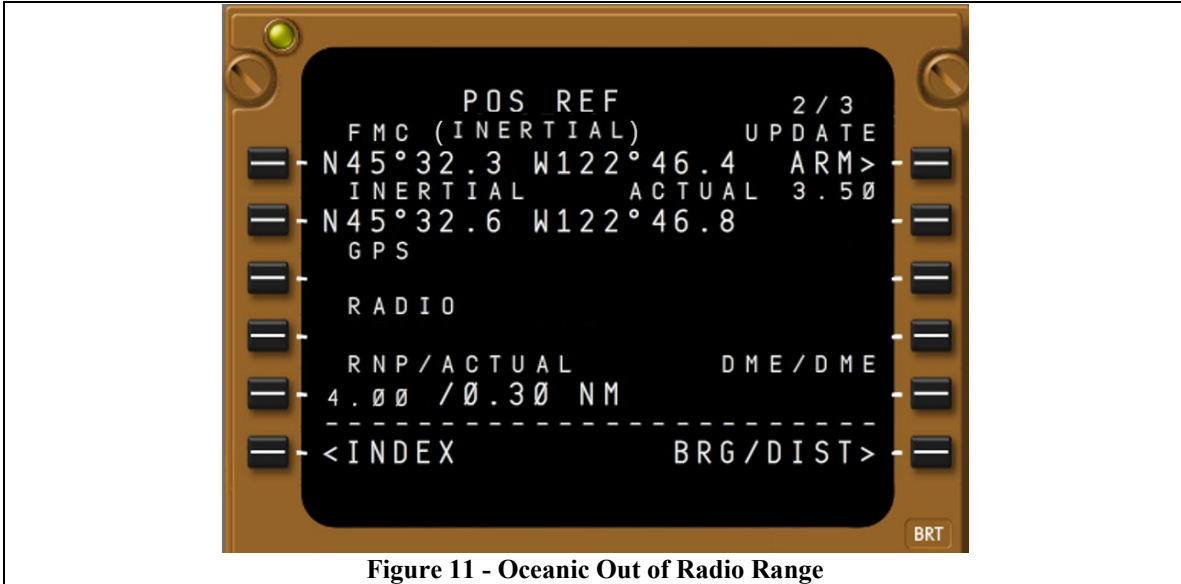
Figure 11 - Oceanic Out of Radio Range

GPS position is shown on the POS REF 2/3 page and updates as the airplane moves. During oceanic operations, when a GPS signal is not available and the airplane is out of range of any radio navaid, both the GPS and RADIO position fields are blank. See Figure 11.

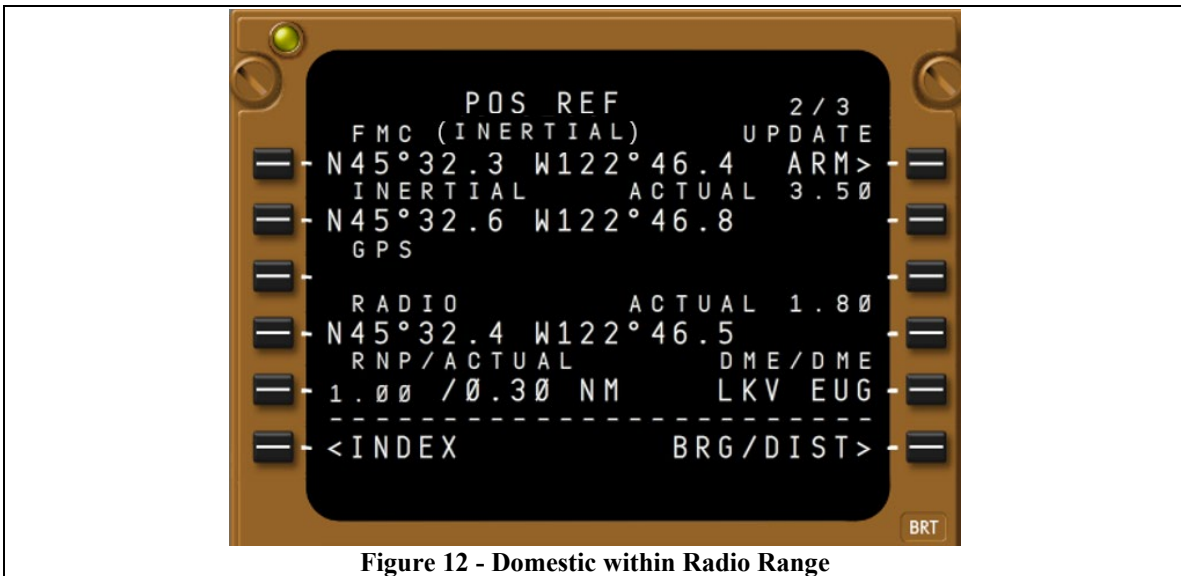
Figure 12 - Domestic within Radio Range

When a GPS signal is not available but the airplane is in range of radio navaids, only the GPS position field is blank. If radio updating is inhibited, the FMC uses inertial as the only navigation source as shown in Figure 12 below.

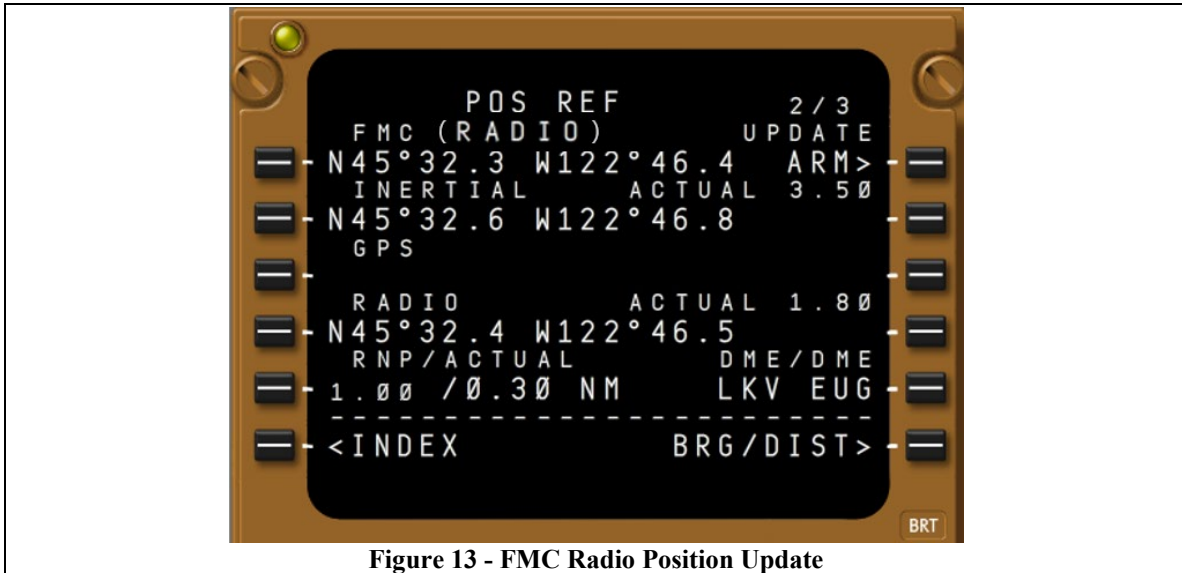
When radio updating is enabled, the FMC uses the radio nav aids as the navigation source as shown in Figure 13 below.

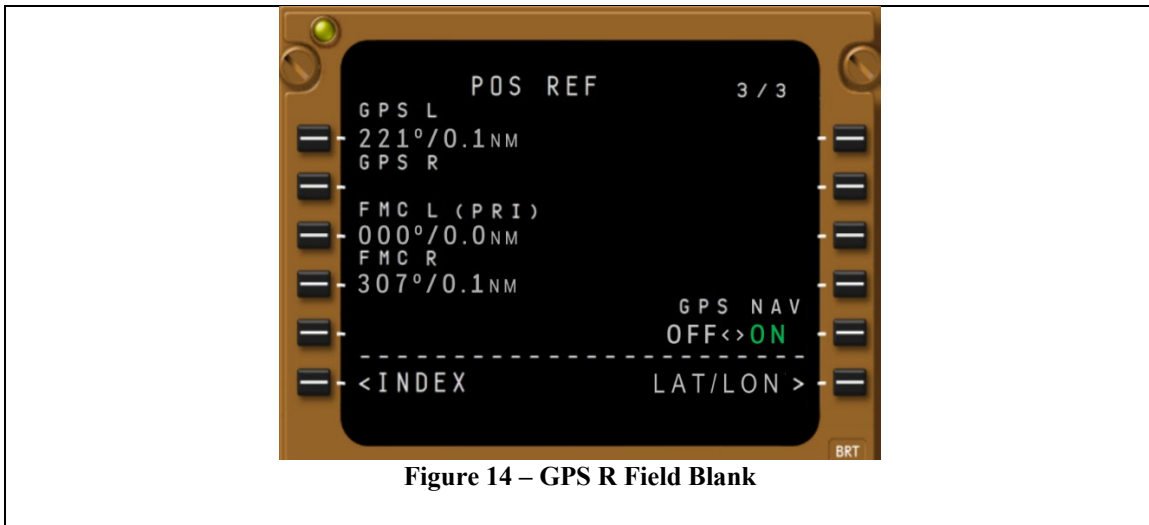
Figure 14 – GPS R Field Blank

If one GPS BRG / DIST is blank, then that GPS has not recovered from the interference, and the FMC is using the other GPS sensor. This can indicate GPS interference is still occurring or that lingering effects remain after the airplane has left the GPS interference area.

If one GPS distance is greater than 0.1, this can be an indication that the GPS position is still affected by GPS interference. Although that GPS is not being used by the FMC for position determination, other systems can still use data from that GPS.

Figure 14 below is an example of a blank value for GPS R.
